Limited Visual Dam Safety Inspection Summary Report

HI - 00052

Kehena Reservoir

May 2006

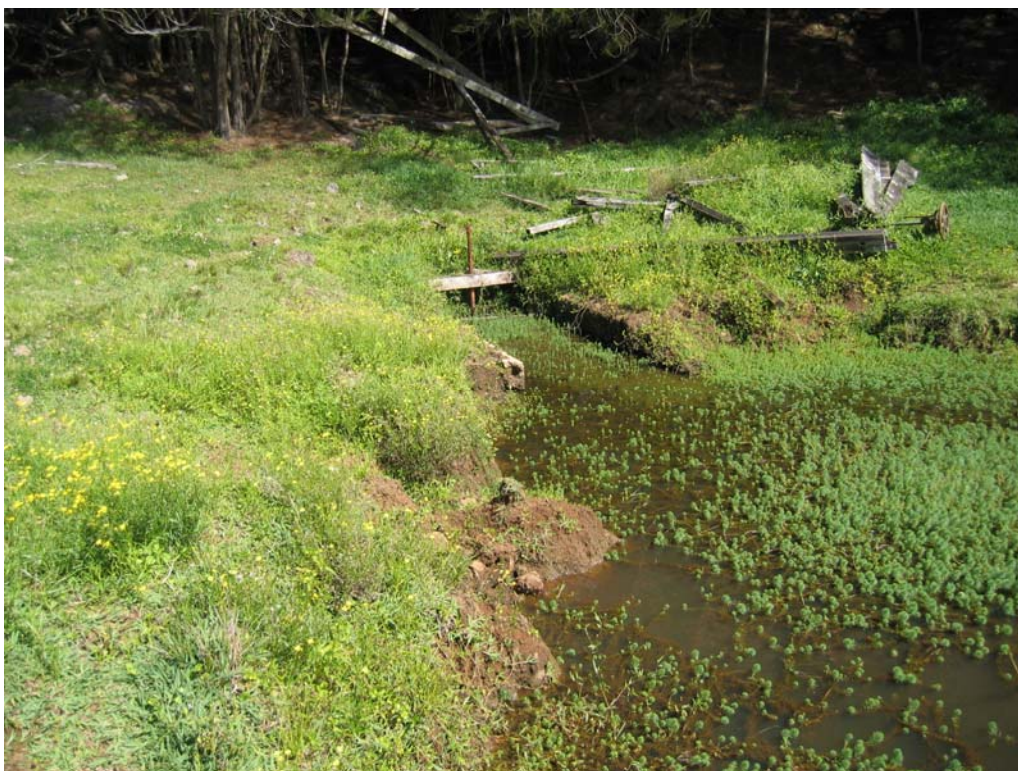
Photo 1 Outlet intake.

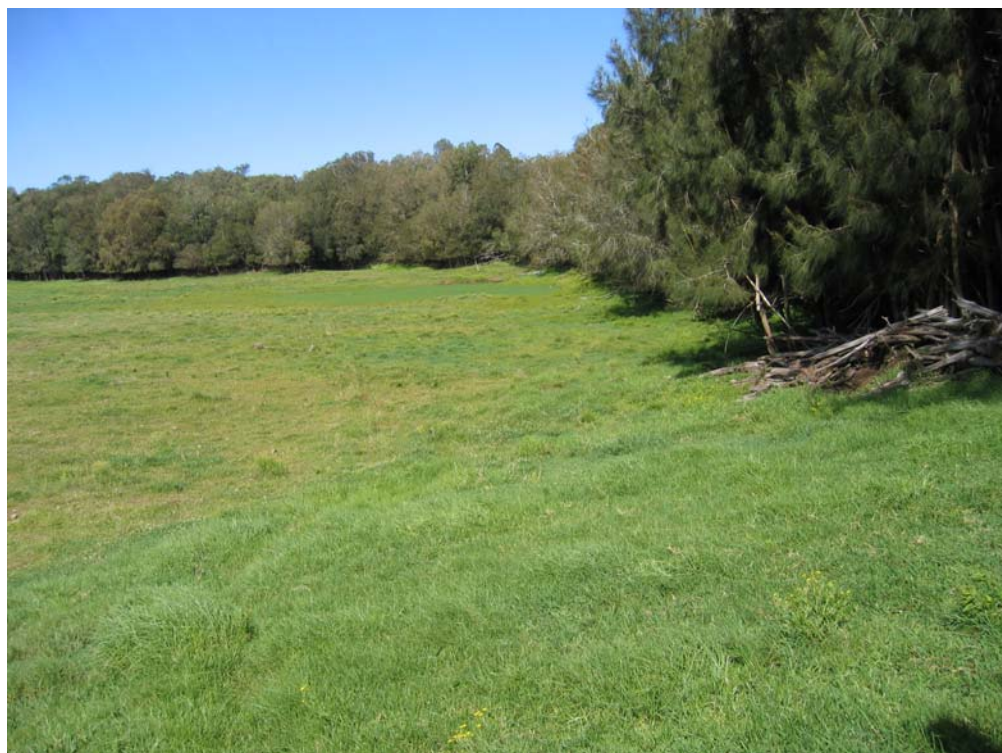
The reservoir level during the inspection was very low; only a few feet of residual pool remains in a small area. There is no staff gage.

Photo 2 Reservoir overview.

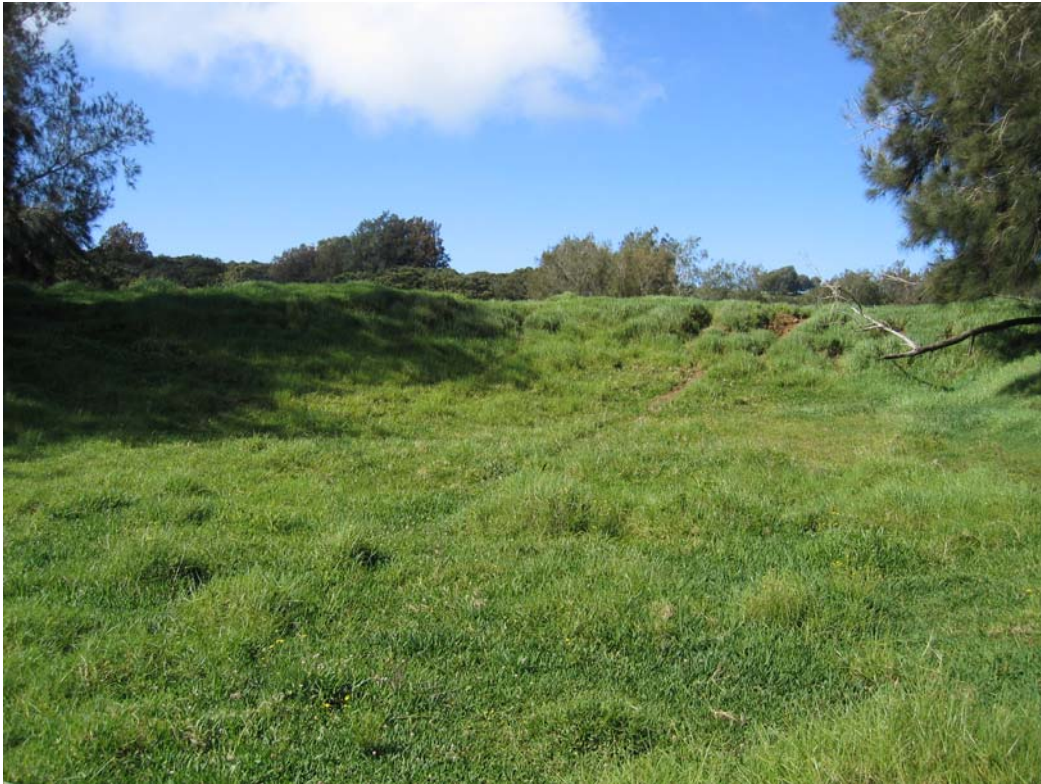
The dam breached, with little downstream damage, sometime during 2003-2004. The dam was originally breached in the 1970's, but the breach was filled and the reservoir was allowed to begin retaining water in the late 1990's to early 2000. The dam began to seep and failed by breaching near the outlet works. The owner's representative stated that they currently do not plan to repair this structure. The flow that enters the reservoir flows into a small residual pond and then out the breach, uncontrolled. The breach is approximately 50 ft wide.

Photo 3 Filled in breach/spillway.

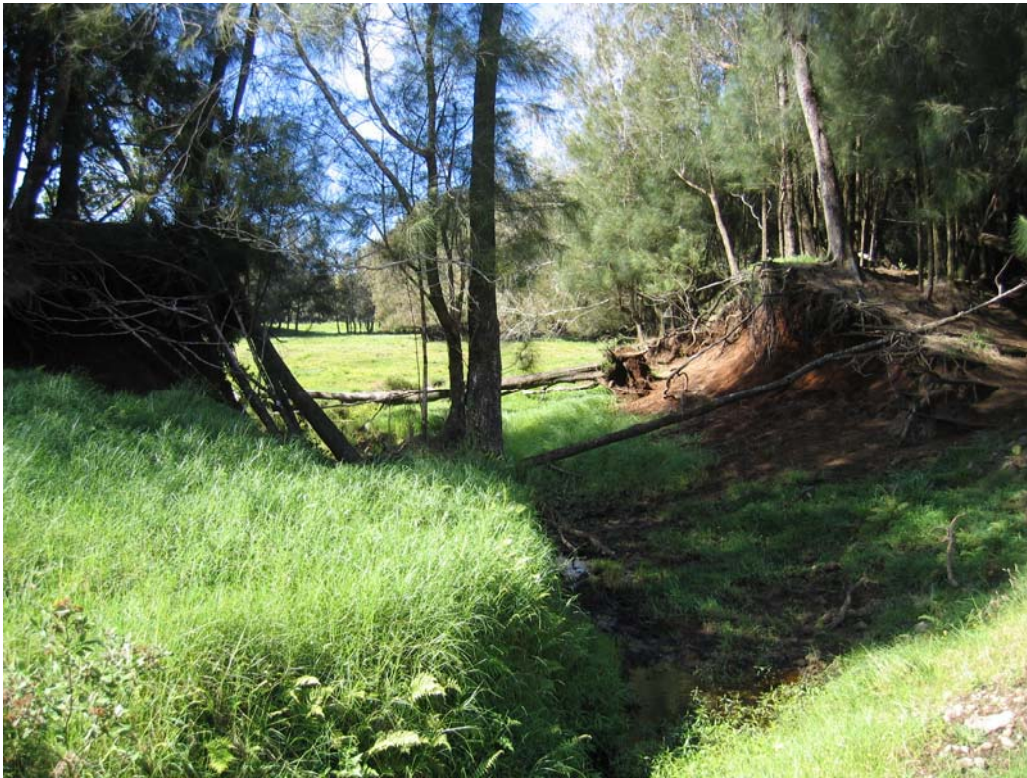
The reservoir and dam features were easily recognizable. The dam appears to have breached, and has approximately 50 foot section of embankment missing.

Photo 4 Breach in dam near outlet works.

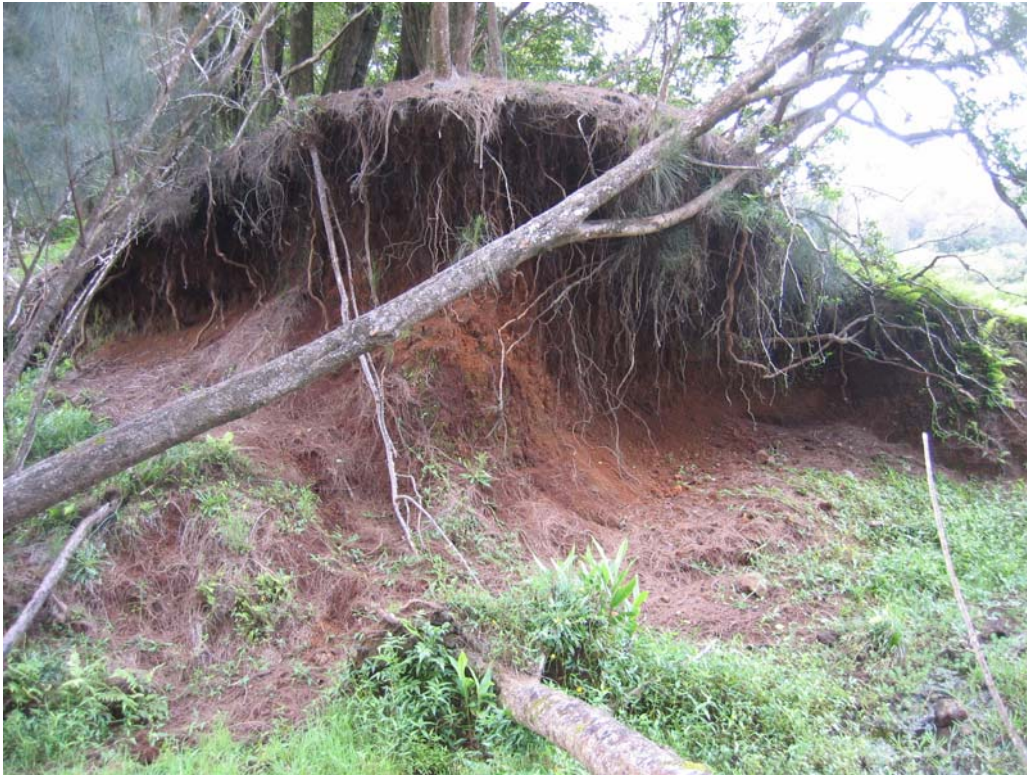
Photo 5 Side slope of breach.

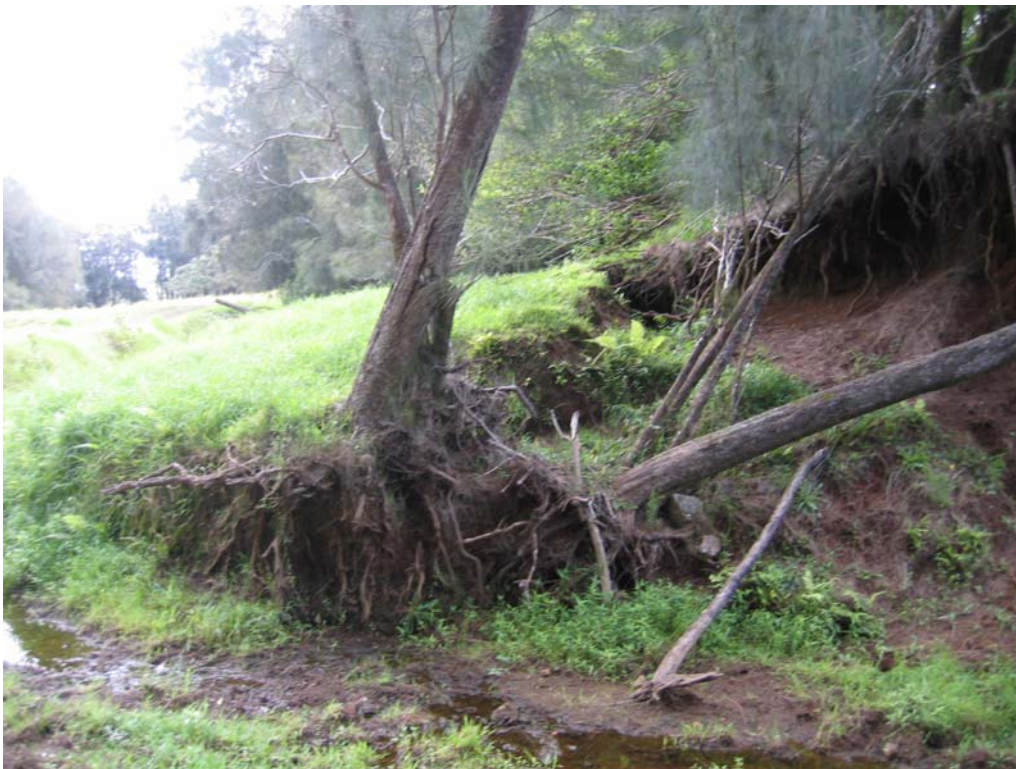
Photo 6 Downstream slope.

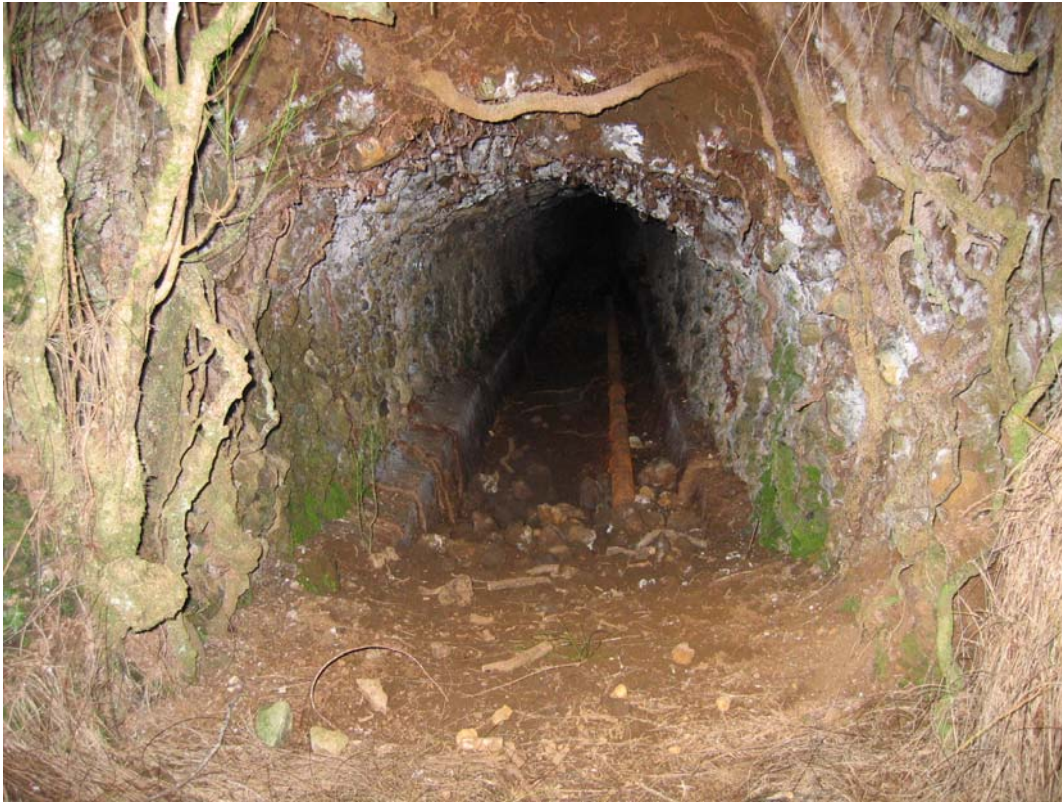
Photo 7 Outlet tunnel, no longer used.

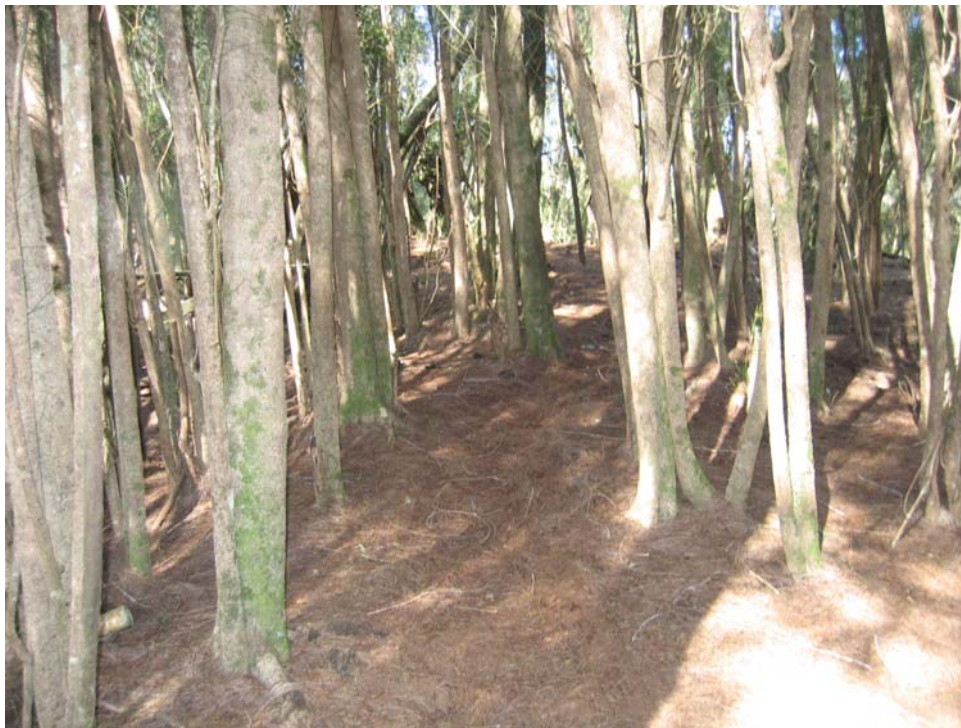
The dam crest was approximately 15 feet wide.

Trees are growing along the crest.

Photo 8 Dam crest.

- a. The dam crest was not inspected.
- b. Portions of the crest were not visible due to high grass and bush vegetation. Clear high vegetation and maintain low to enable easy visual inspection.
- c. Tree(s) were observed along the dam crest. Trees have been identified as the probably cause of piping failures, and can possibly cause severe damage to the embankment if they are uprooted during a high winds. Corrective action is required to remove the tree hazards from the dam. Acceptable remedies include removal of the tree and its root structure down to a 2" diameter and reconstructing the damaged embankment section. All repair work shall be accomplished as per the requirements of licensed geotechnical or structural engineer. Routinely monitor the damaged area for signs of settlement and seepage.
- d. The dam has breached and no longer retains a pool.
